World Trade Center Building Performance Study:

*Data Collection, Preliminary
Observations, and
Recommendations*

FEMA 403 / May 2002

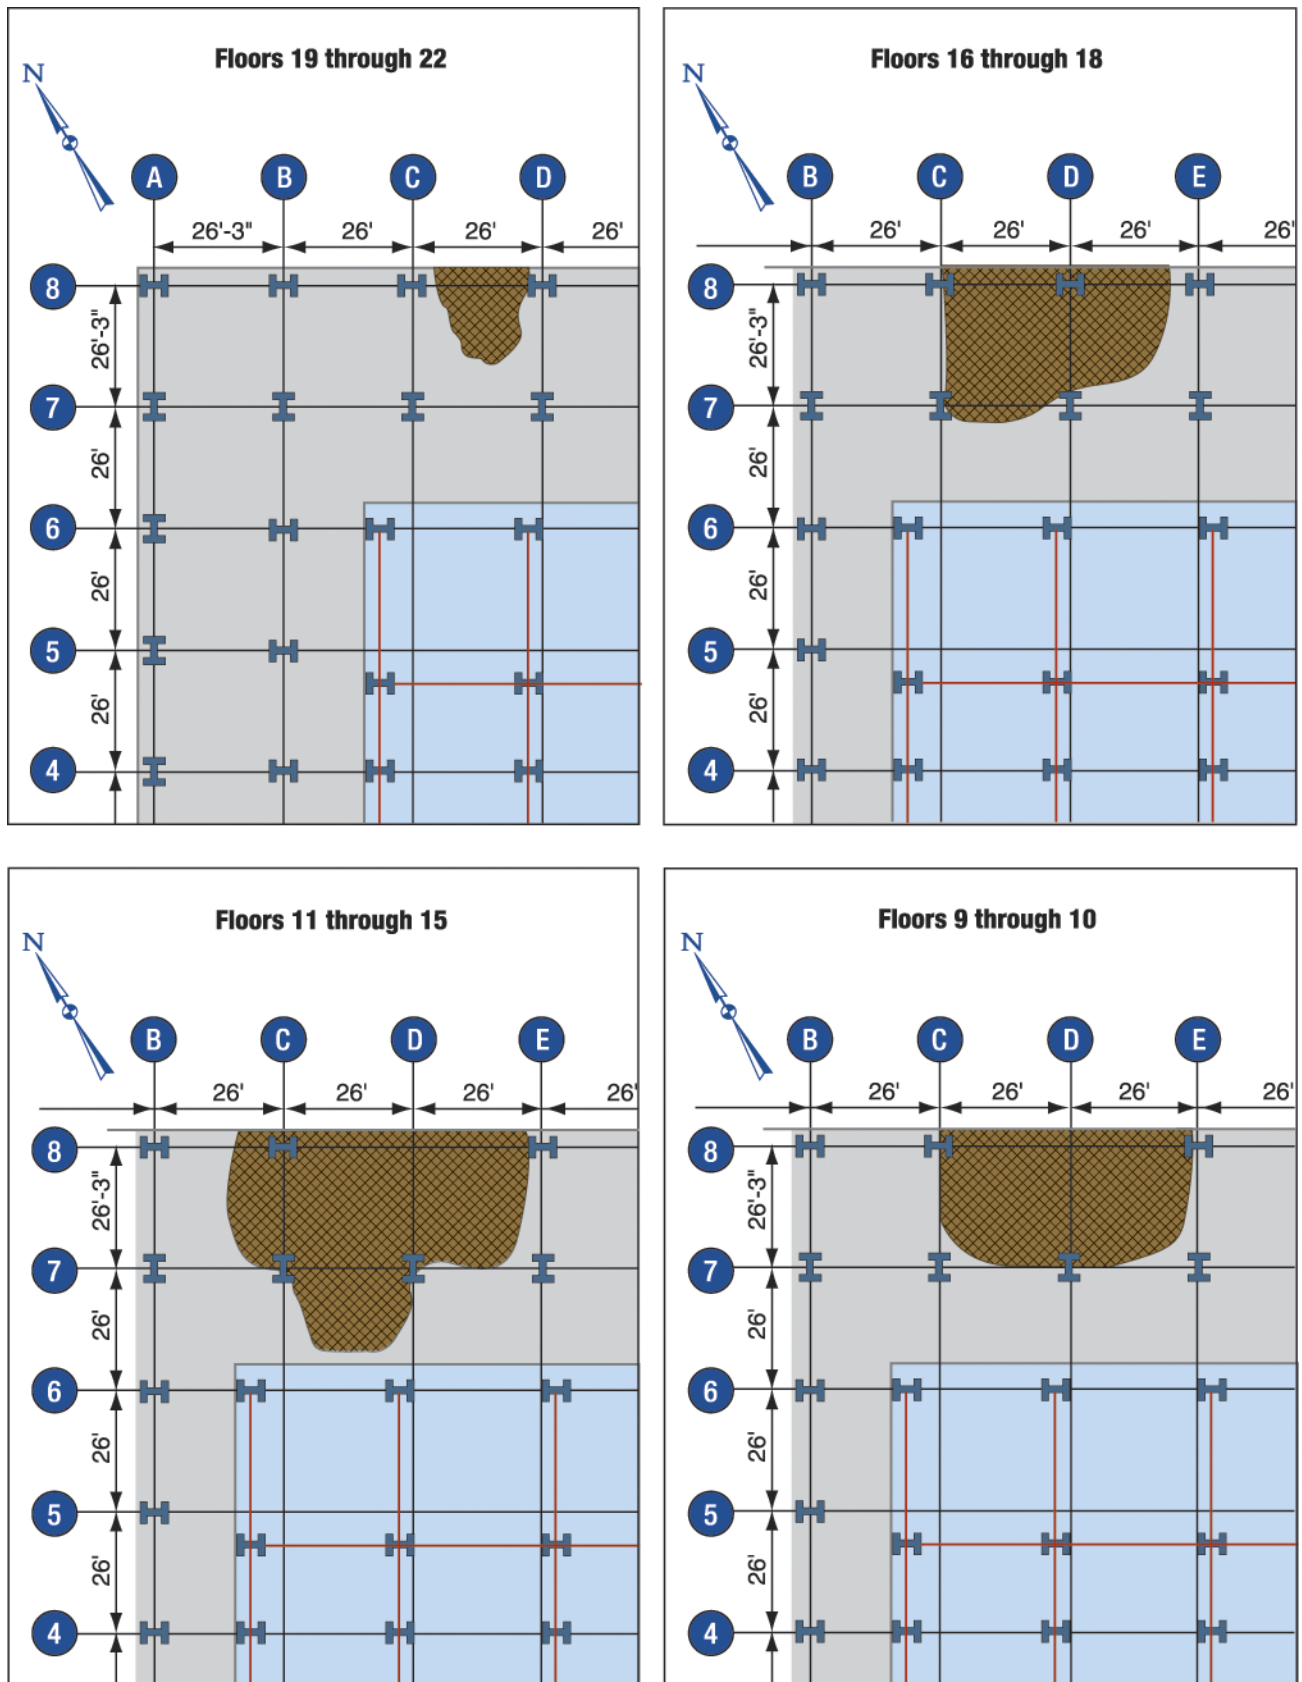
Figure 6-5 Approximate zones of damage – 19th through 22nd floors, 16th through 18th floors, 11th through 15th floors, and 9th through 10th floors.

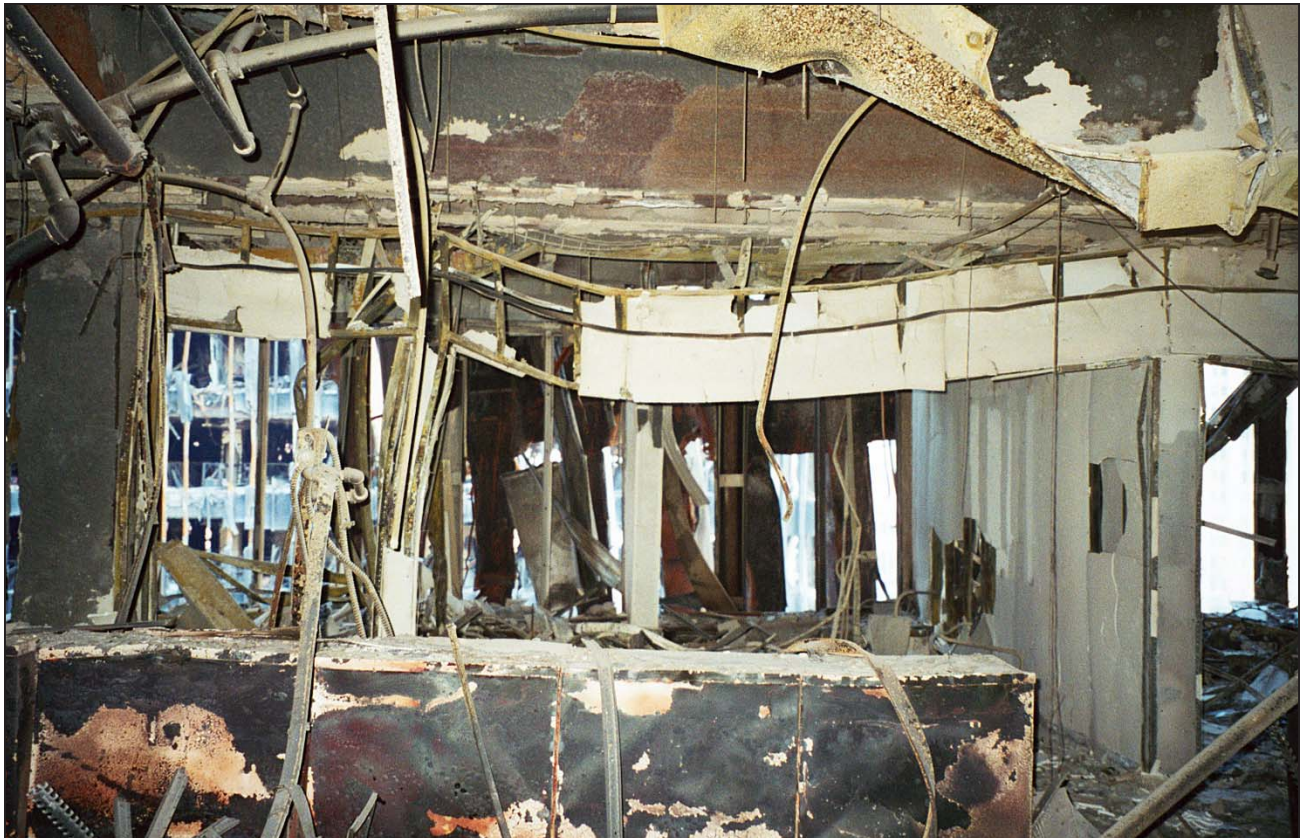
Figure 7-5 Interior damage at floor 20 of WFC 3.

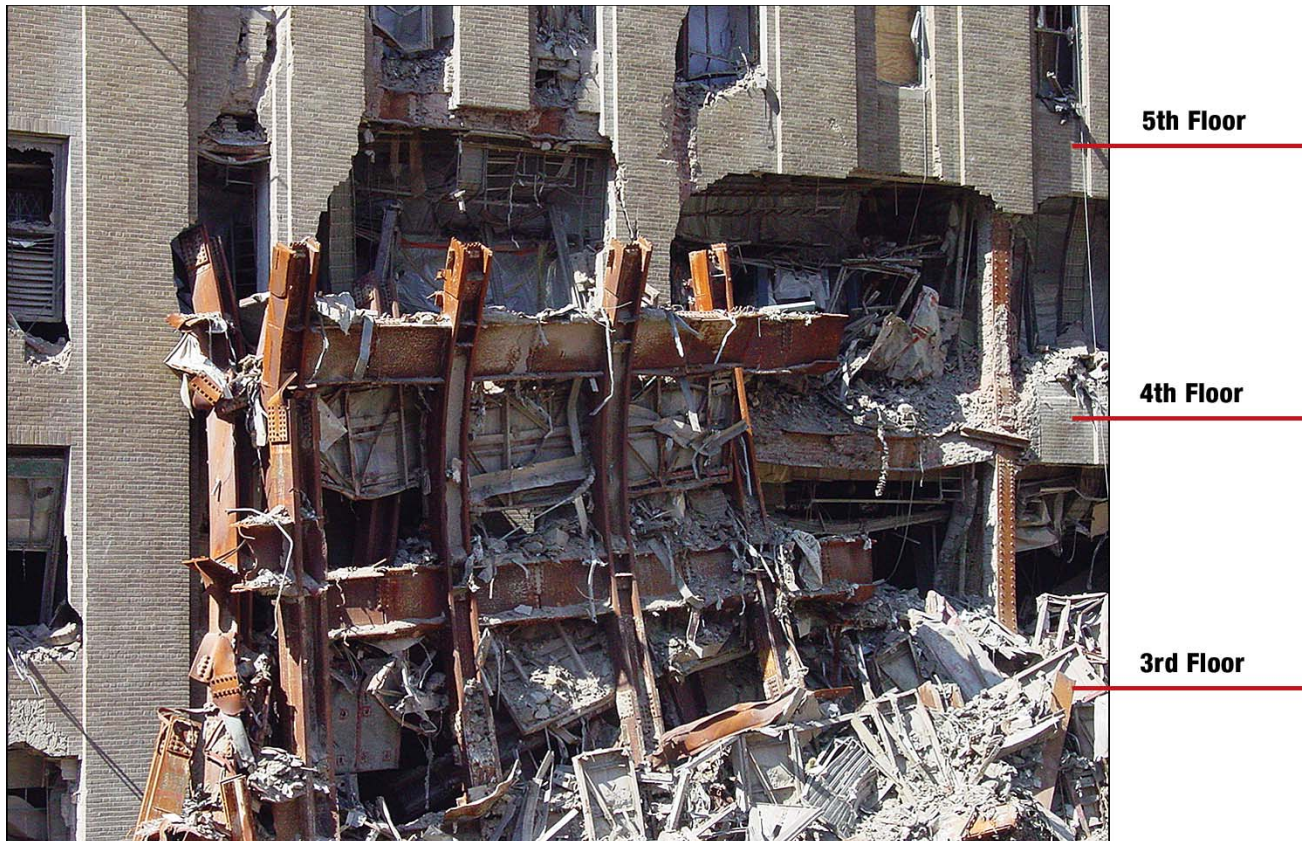
Figure 7-7 Verizon building – damage to east elevation (Washington Street) due to WTC 7 framing leaning against the building.

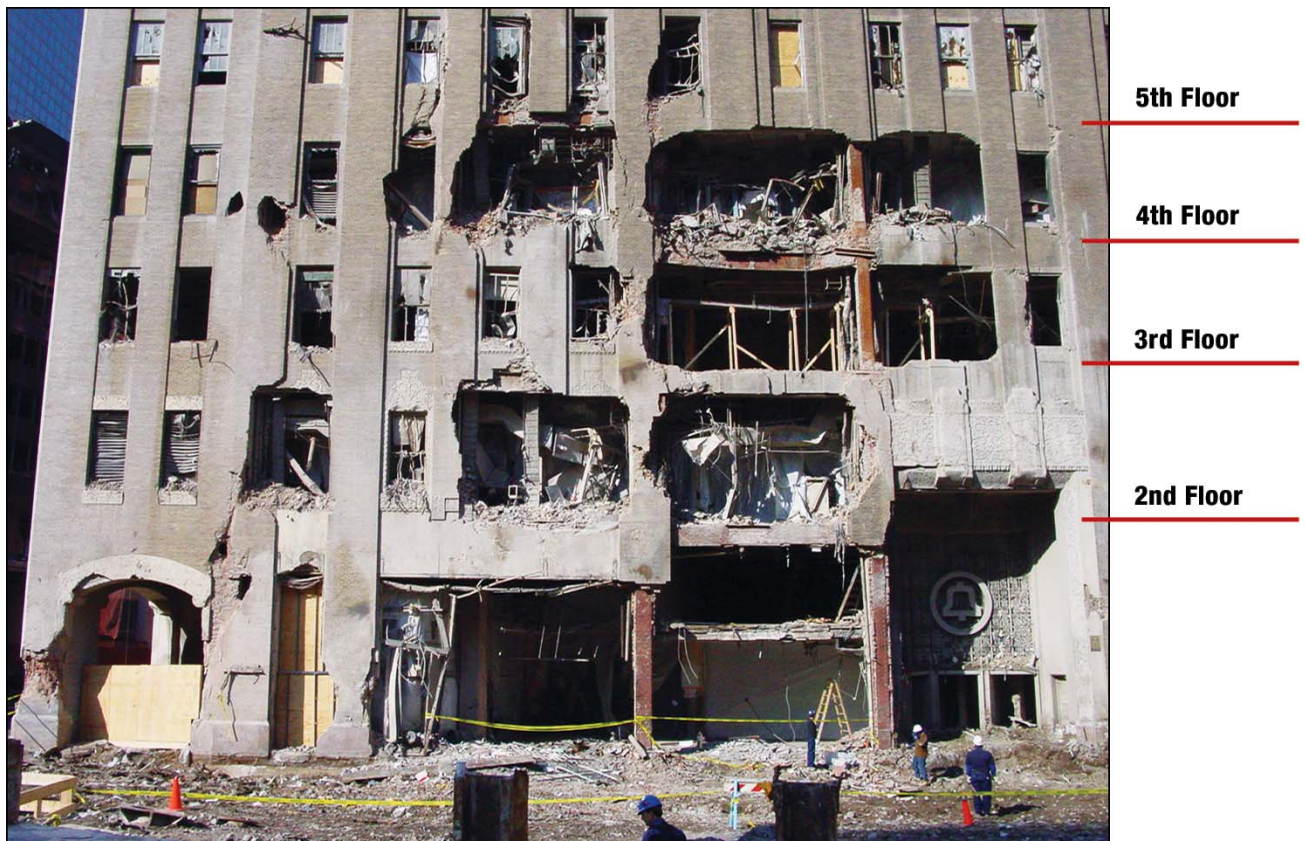
Figure 7-8 Verizon building – damage to east elevation (Washington Street).

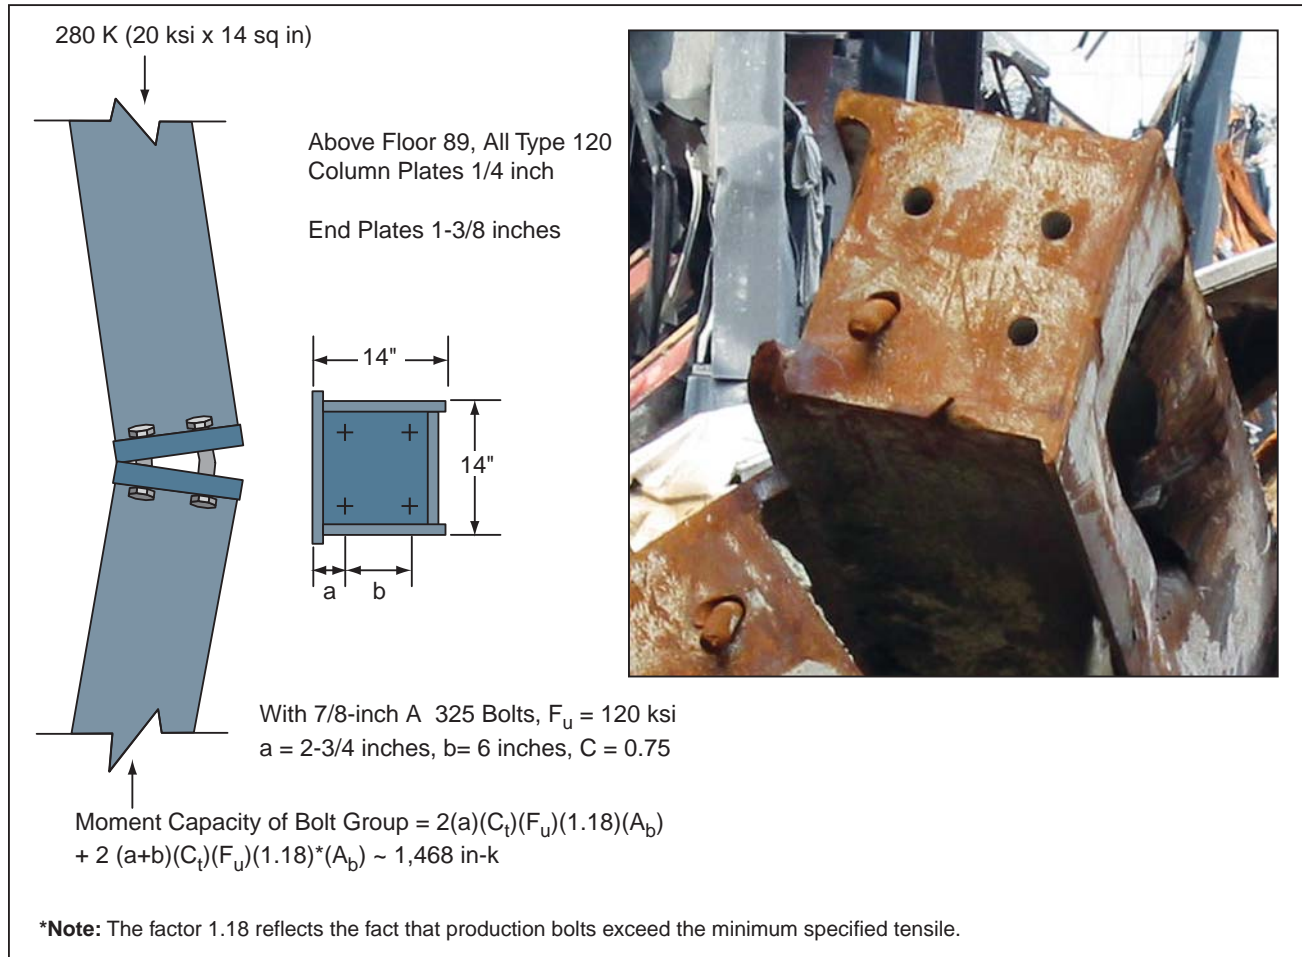
Figure B-7 Bent and fractured bolts at an exterior column four-bolt connection.

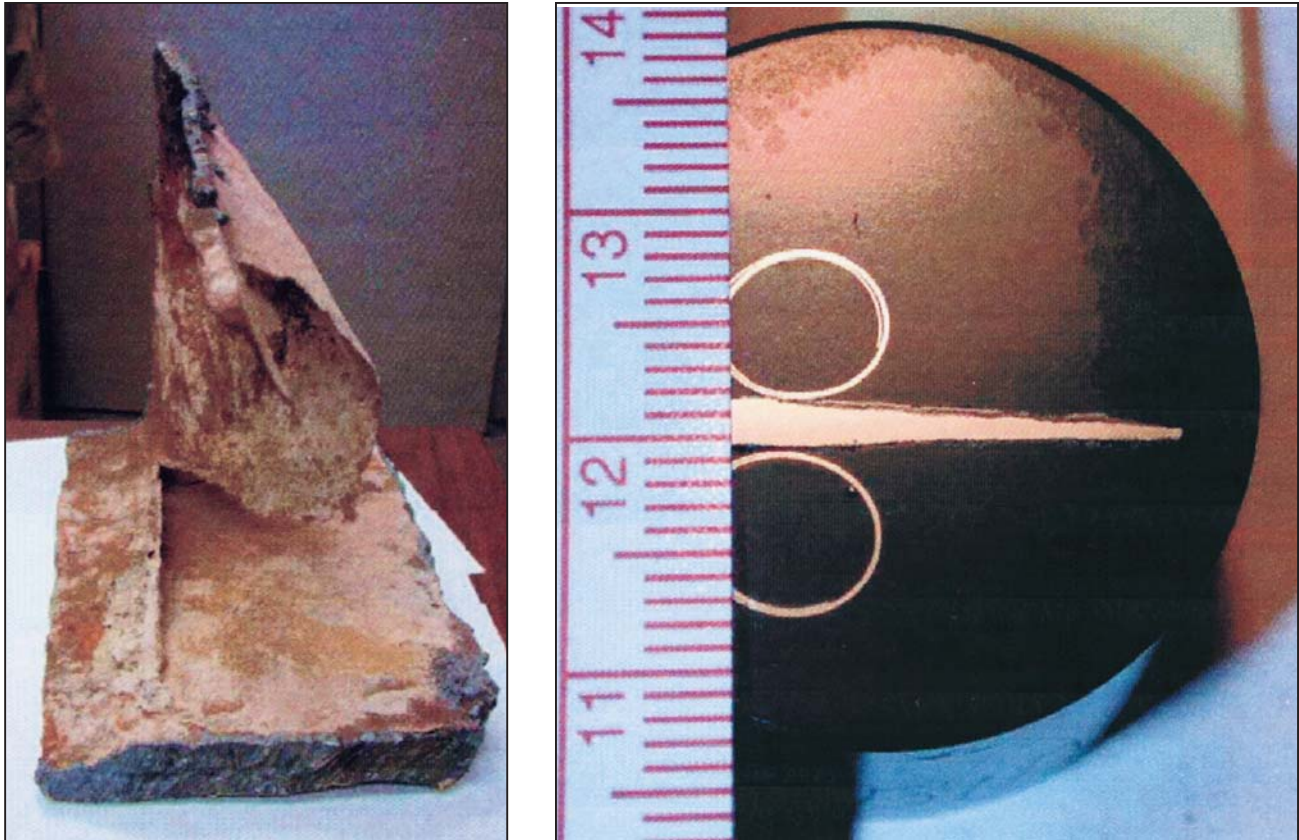
The origin of the steel shown in Figure C-9 is thought to be a high-yield-strength steel removed from a column member. The steel is a high-strength low-alloy (HSLA) steel containing copper. The unusual thinning of the member is most likely due to an attack of the steel by grain boundary penetration of sulfur forming sulfides that contain both iron and copper. Figures C-10, C-11, and C-12 show the region of severe corrosion at different levels of magnification.

Figure C-9 Qualitative chemical analysis.

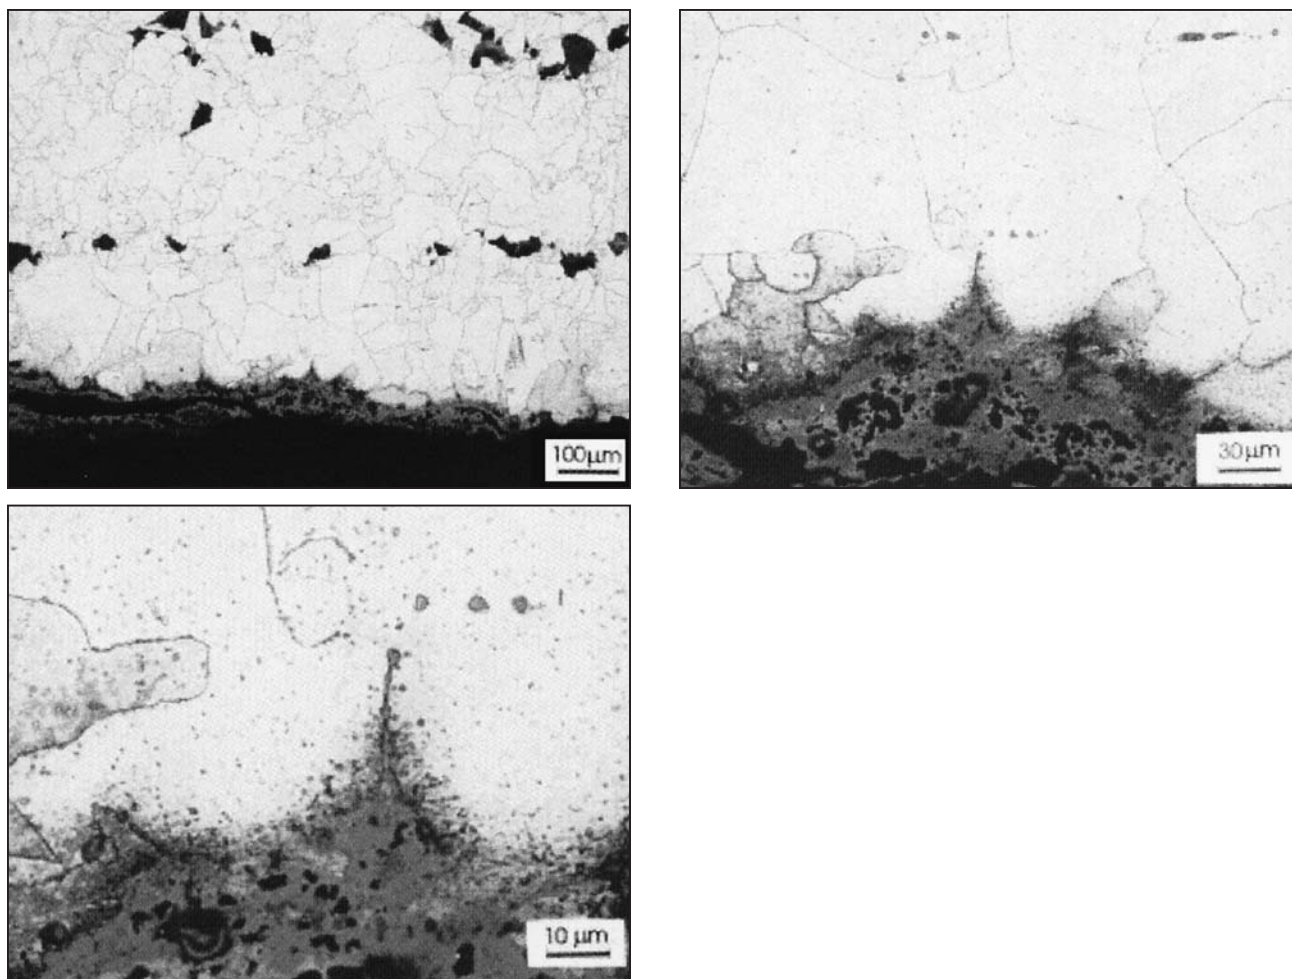
Figure C-11 Microstructure of a typical region showing the surface and grain boundary corrosion attack of Sample 2.
